**RUSTIC HILLS LAKE DAM
JEFFERSON COUNTY, MISSOURI
MO 30467**

PHASE 1 INSPECTION REPORT NATIONAL DAM SAFETY PROGRAM

Rustic Hills Lake Dam ~~Jefferson County, Missouri~~
(MO#30467), Mississippi-Kaskaskia-St. Louis
Basin, Jefferson County, Missouri. Phase
I Inspection Report.

Name of Dam: Rustic Hills Lake Dam
State Located: Missouri
County Located: Jefferson
Stream: Tributary La Barque Creek
Date of Inspection: 5 July 1978

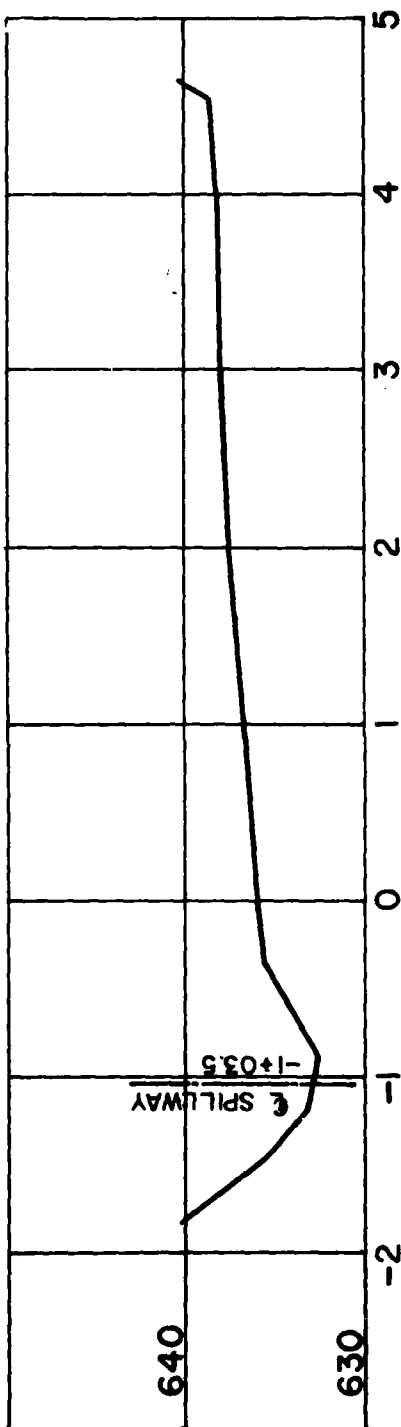
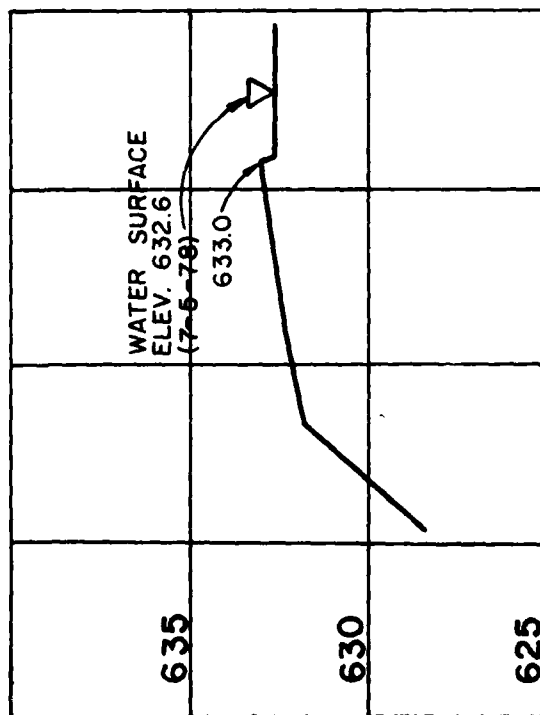
RUSTIC HILLS LAKE
DAM & SPILLWAY PROFILES

b. Dam. The visible portions of the upstream and downstream slopes (see Photos 1 and 2) of the dam appeared to be in satisfactory condition with the exception of some minor surface erosion of the downstream slope in a cleared area near the center of the dam. A substantial cover of small trees and brush exists on most of the downstream slope. Several small trees were also present on the upstream slope. Seepage, as evidenced by wet ground and pockets of water with cattails (see Photo 5), was noticed in several areas adjacent to the downstream slope. There was no riprap protection to prevent erosion at the water line on the upstream slope. The top of dam, as determined by survey, was found to have a continuous upward slope from the spillway toward the left abutment. A profile of the dam crest extending through the spillway section is shown on Plate 2.

course, approximately 200 feet below the dam. A profile of the spillway channel through the control section is shown on Plate 2.
